B.6.3 Domestic Monitoring Wells

Proposed Strada Shelburne Pit/Quarry| Appendix A and B: Field Program Methodology and Results

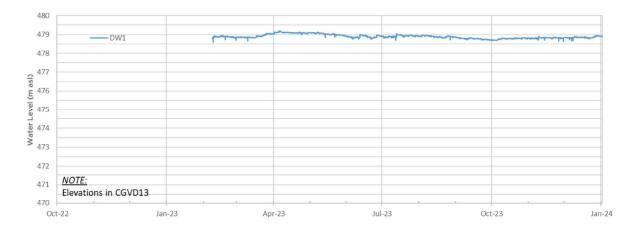
Figure B.46: Hydrograph of water levels at Domestic Well DW1, masl.

Water level monitoring in five domestic water wells initiated in 2022 and the monitoring data measured to date is show in Figure B.46 through Figure B.50. The logger at DW2 has been removed several times during the course of the monitoring, additional measures are being reviewed to ensure future loggers are not removed.

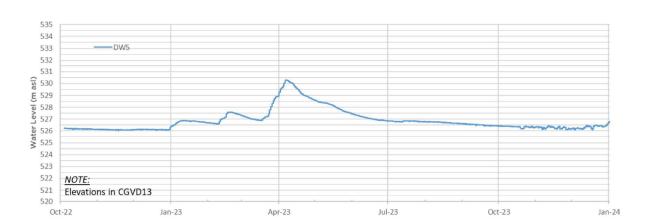
Figure B.50: Hydrograph of water levels at Domestic Well DW5, masl.
