## Streamflow and Water Quality Measurements

Source: Excerpts from Niagara Escarpment Baseflow Study, Nottawasaga Valley Conservation Authority, Jan 27, 2009

Property of  
**HUNTER and ASSOCIATES**  
Environmental and Engineering Consultants  
Website: [www.hunter-aes.com](http://www.hunter-aes.com)

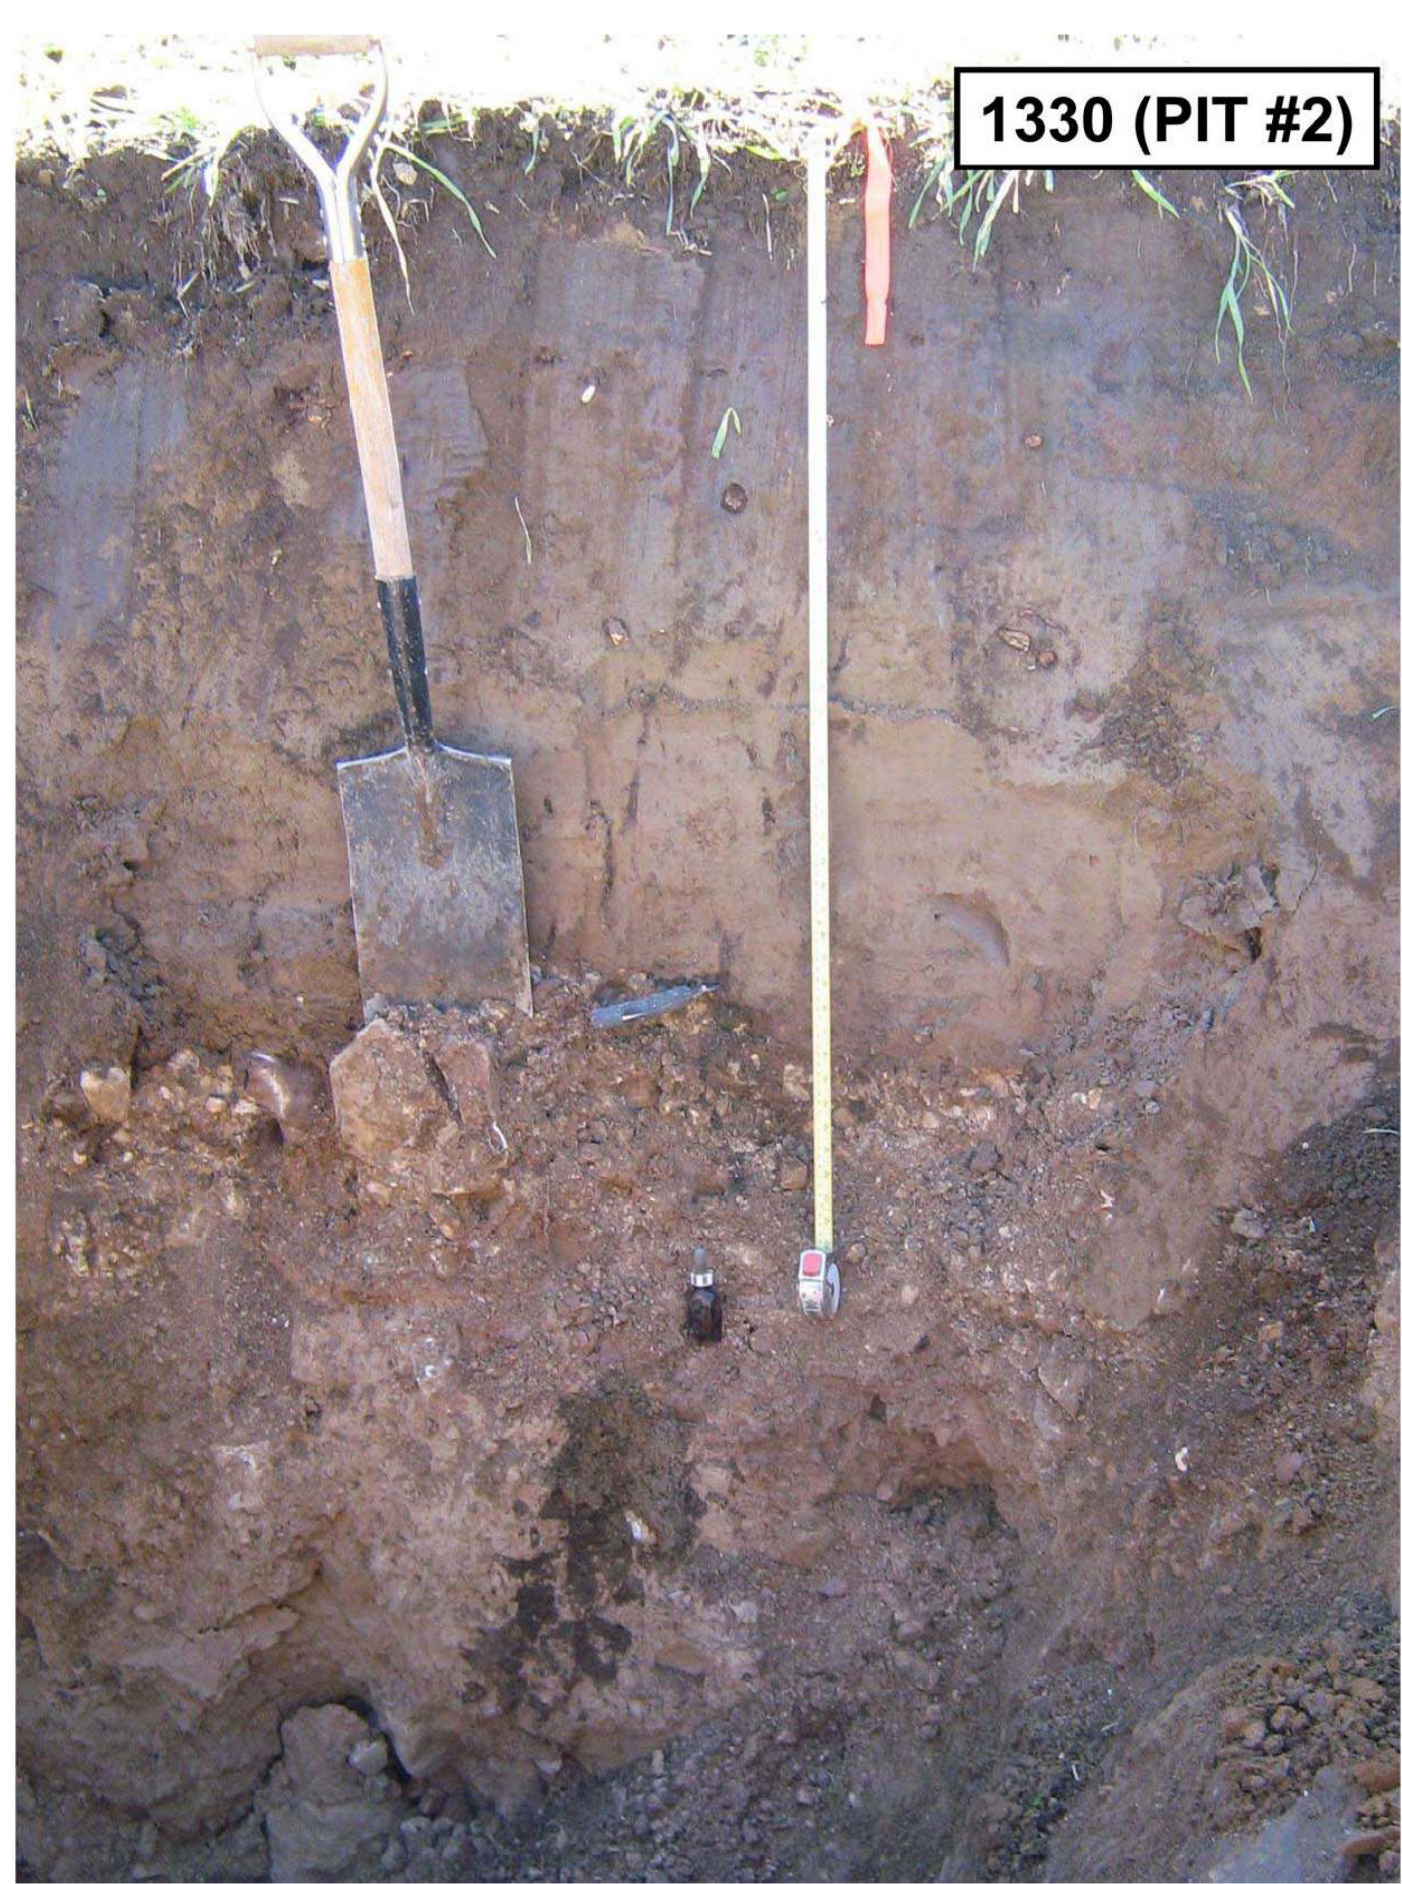
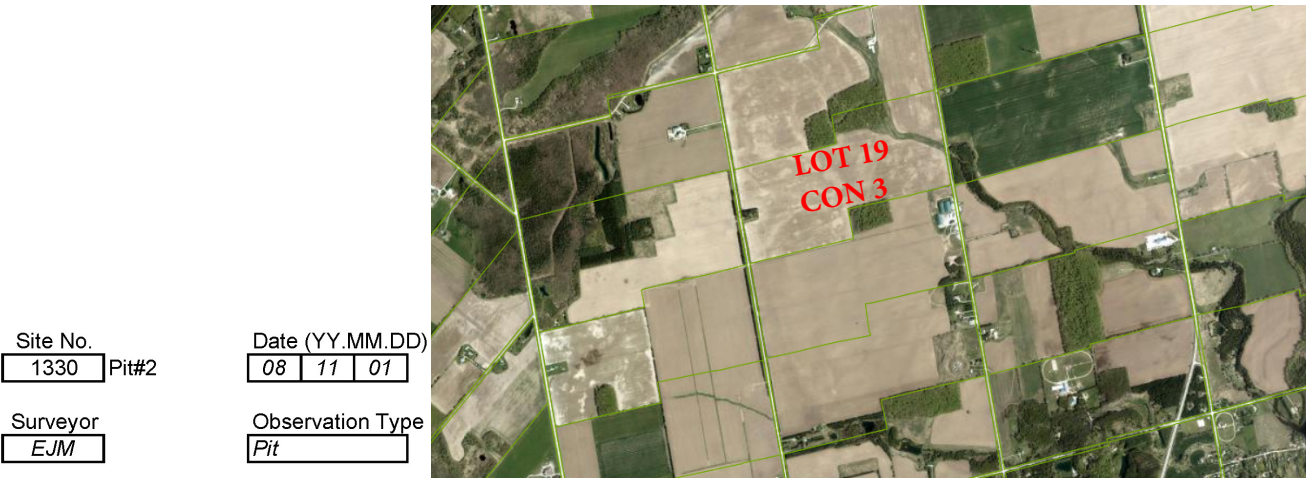
Site No. 1330 Pit#2 Date (YY.MM.DD) 08 11 01  
Surveyor EJM Observation Type Pit

MODE OF DEPOSITION NO. 1 AL NO. 2 MT NO. 3  
SLOPE CLASS A DRAINAGE CLASS W SLOPE POSITION 7 SLOPE % 0.5 LENGTH 100+  
STONINESS 0 ROCKINESS 0

| HORIZONS | | | | DEPTH (cm) | | COLOURS | | % | LAB TEXTURE | CONSISTENCY |
| D | Ma | Suffix | Mod. | Upper | Lower | Matrix Colours | Mottle Colours | C.F. | | |
| | A | p | | 0 | 20 | 10YR3/3 | | 0.0 | SiL | |
| | B | m | | 20 | 43 | 10YR4/4 | | 0.0 | SiL | |
| | B | t | | 43 | 86 | 10YR5/4 | | 0.0 | L | |
| II | B | t | | 86 | 123 | 7.5YR4/6 | | 46.0 | GrfSL | |
| II | C | k | | 123 | 150 | 10YR6/4 | | 44.6 | GrfSL | |

NOTES: Test Pit 2  
small grain - 2008-9  
many stones (25-60cm) in IIBt soil horizon
